AN EVALUATION OF EXPERIMENTAL
REHABILITATION WORK,
REDWOOD NATIONAL PARK

TECHNICAL REPORT
JULY 1987

Redwood National Park Watershed Rehabilitation
Technical Report Number 19

National Park Service
Redwood National Park
Arcata, California
July 1987

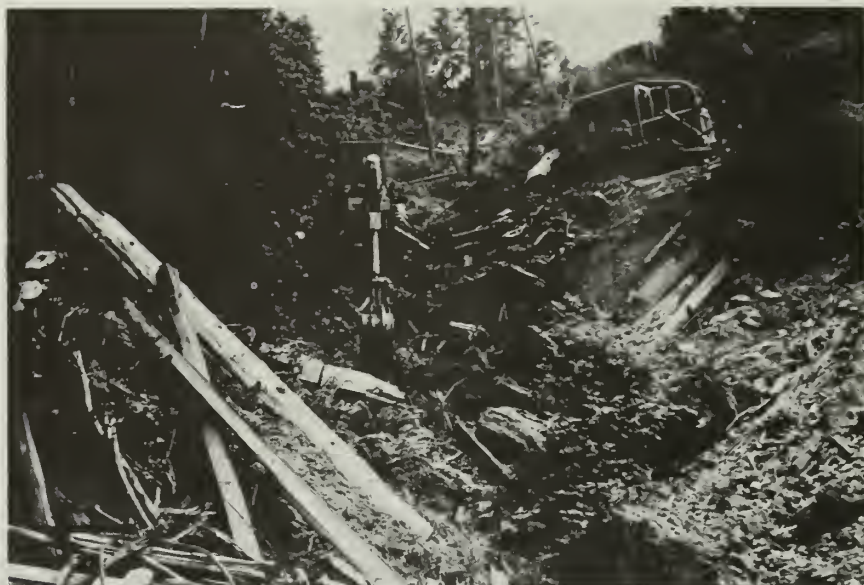
Fig. 5. Tractor and backhoe excavating skid trail stream crossing.

Fill in skid trail crossings was excavated by backhoe and redistributed to stable locations by crawler tractor (Figure 5). The tractor was also used to perform preliminary excavations and to winch and remove organic debris. Total cost for the excavation of skid trail crossings was \$6,400 or \$7.70 per cubic yard (Table 4).

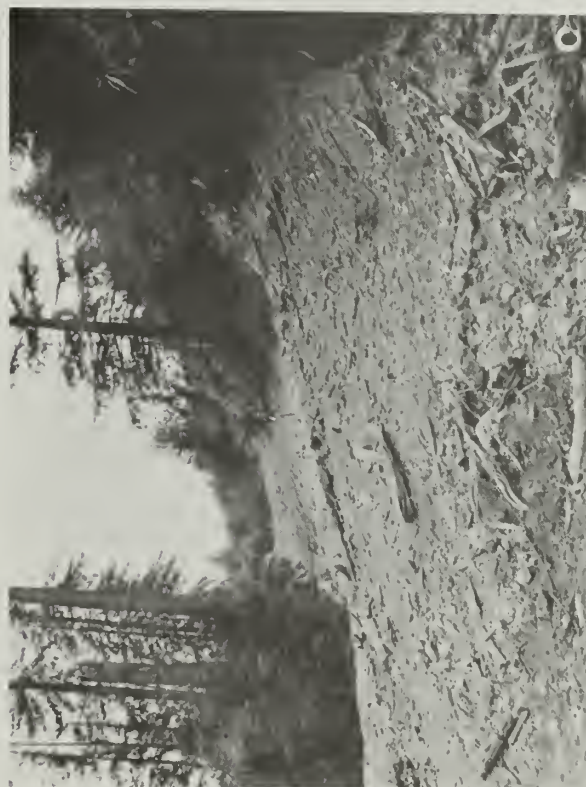
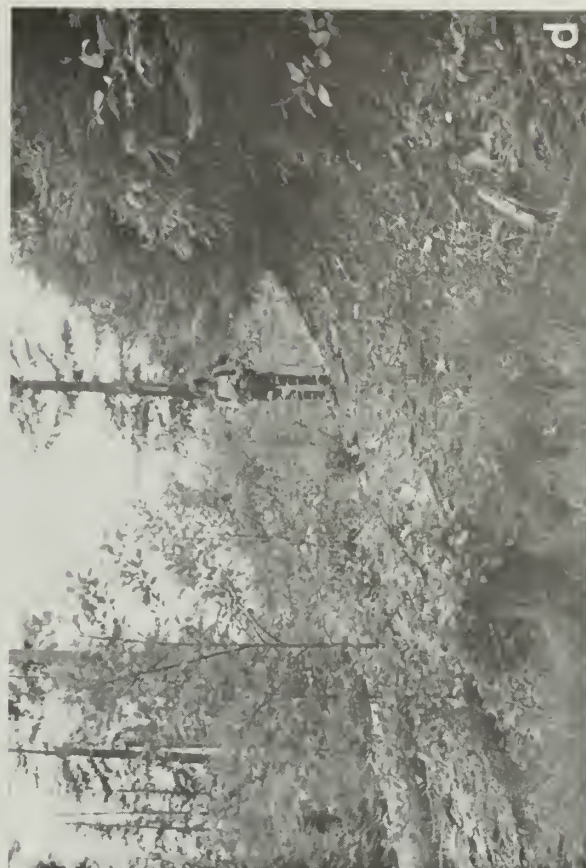
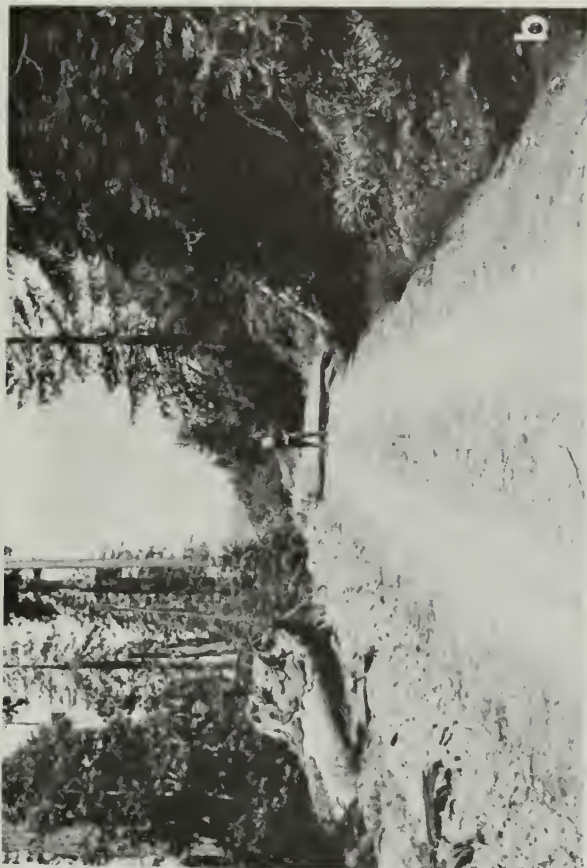
Fig. 6. Outslipping a segment of the L-1-5 road. A) diagrammatic sketch of road outslipping showing excavation of road fill and burial of inboard ditch and cutbank, B) before heavy equipment treatment (May 1979), C) immediately after outslipping and D) two year later (June 1983). All photos taken from the same viewpoint.

Several pieces of equipment were used to outslope the L-1-5 (Figure 6). Before outsloping, a blade-mounted chisel tooth on the tractor was used to decompact the western half of the road to a depth of about 12 inches. Fill material was then removed from the outside edge of the road with a drag-line crane and either loaded into dump trucks or deposited and graded uniformly up the cutbank. Because of insufficient stable storage area, dump trucks were used to end-haul much of the excavated fill to a disposal site (Figure 4). Approximately half of the total length of outsloped road required end-hauling.

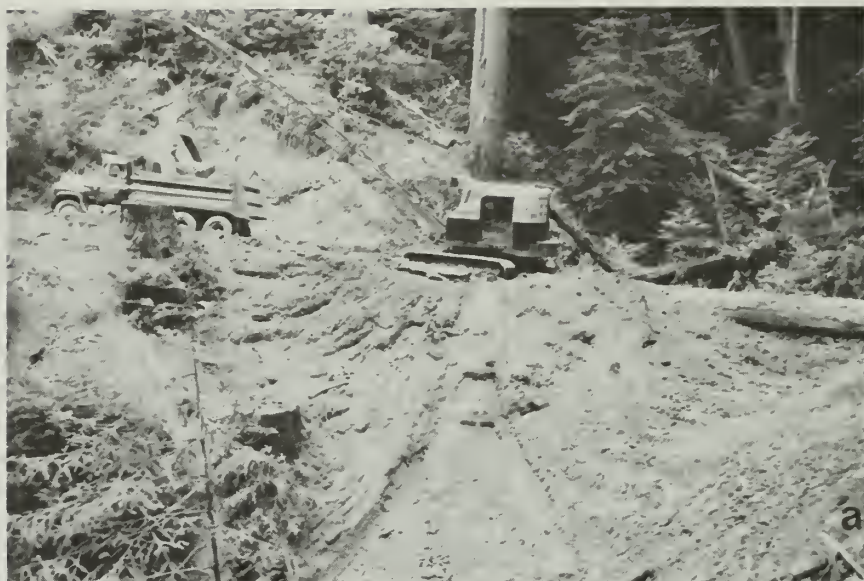
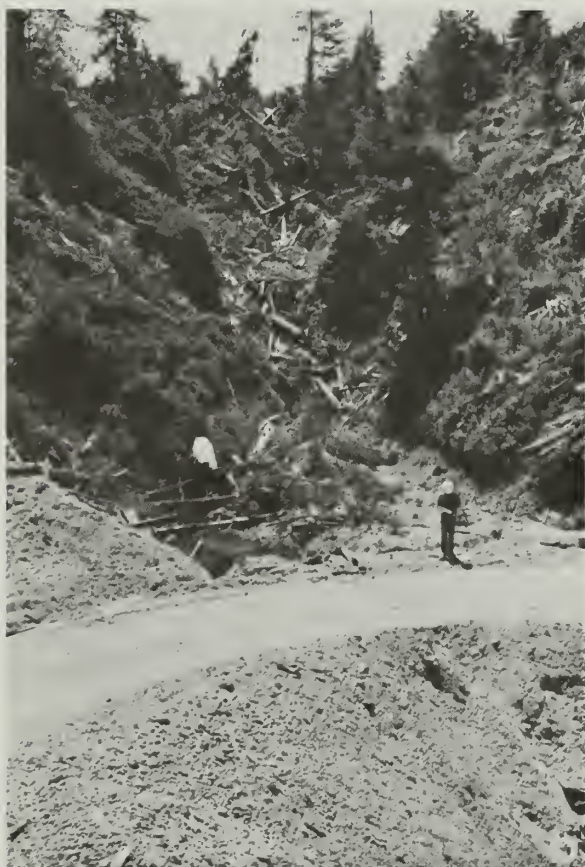
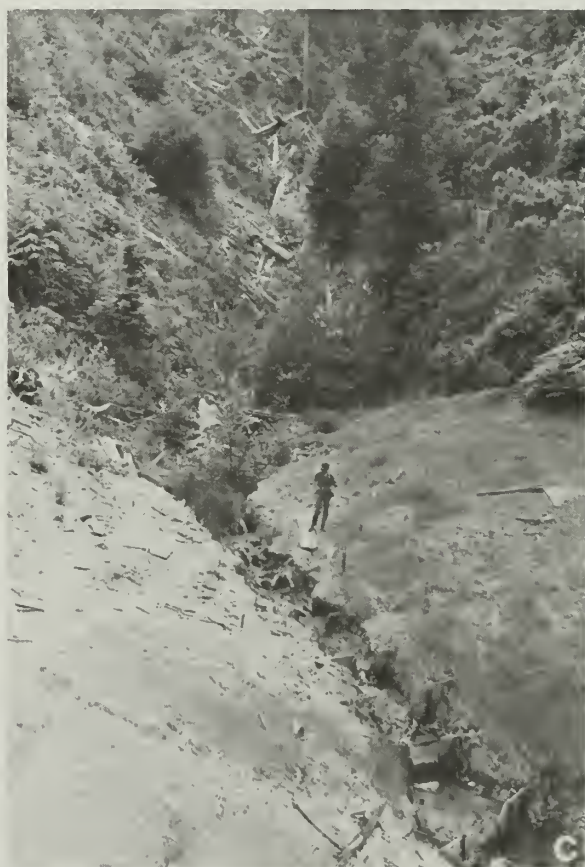
Fig. 7. Stream crossing excavation on the L-1-5 road. A) dragline crane excavates material from the crossing and places it in dump truck for endhauling to nearby storage area, B) before stream crossing excavation and C) after stream crossing excavation. Photos B and C were taken from the same viewpoint.

The four stream crossings on the L-1-5 were excavated by a drag-line crane, with finish work completed by a backhoe (Figure 7). Much of the excavated material had to be end-hauled due to insufficient stable storage area adjacent to the worksites. The amount of fill removed from the crossings ranged from 280 to 500 cubic yards. Costs varied from \$1,200 to \$1,500, averaging \$1,320 per stream crossing (\$3.80 per cubic yard of material removed) (Table 6). Total cost to excavate the four stream crossings was \$5,300.

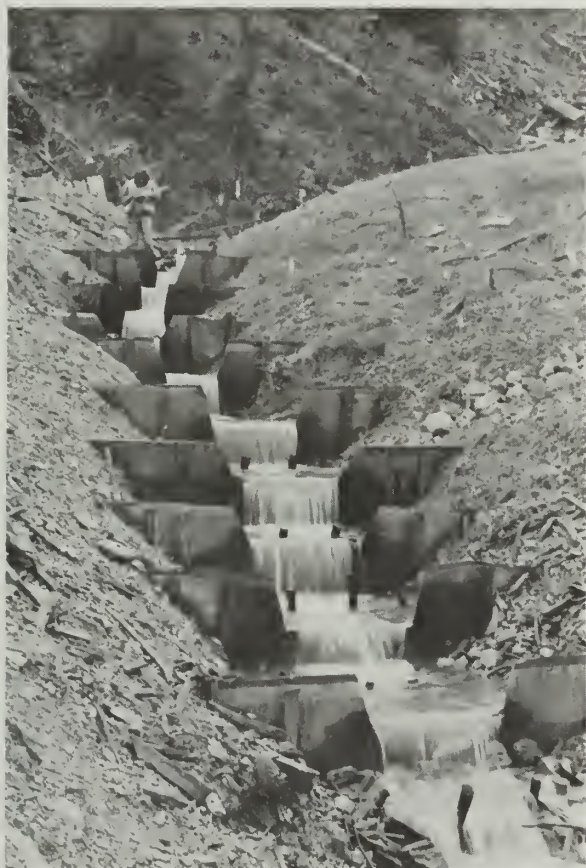
Fig. 8. Redwood board checkdams in an excavated stream crossing, L-1-5 road.

placed in six excavated stream channel crossings (Figure 8). Submerged spillways were installed at three locations. Rock armor, secured with stakes or chicken wire, was used to protect portions of three stream crossings and four drainage ditches (Figure 9).

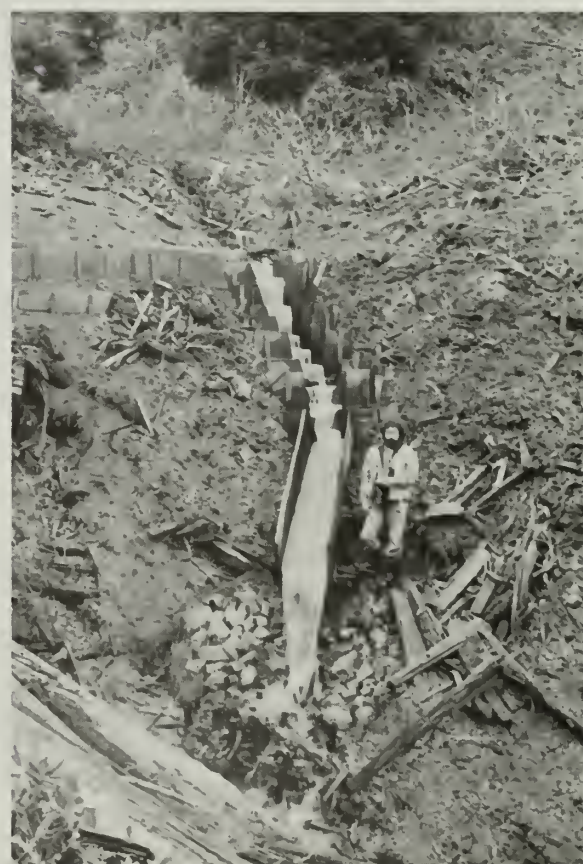
Fig. 10 (right). Water ladder, flume and rock energy dissipater constructed in incompletely excavated skid trail stream crossing.

To reduce stream channel adjustment, wood was secured in or along channel banks. Log deflection points, board deflection points, notched logs, a log energy dissipater and a log retaining wall accounted for seven percent of the total contract cost. In addition to tasks completed by the contractor, park personnel constructed a flume at worksite S2 (Figure 10) to carry water over a steep reach of excavated channel. The flume took approximately five hours (\$34.00) to build and install.

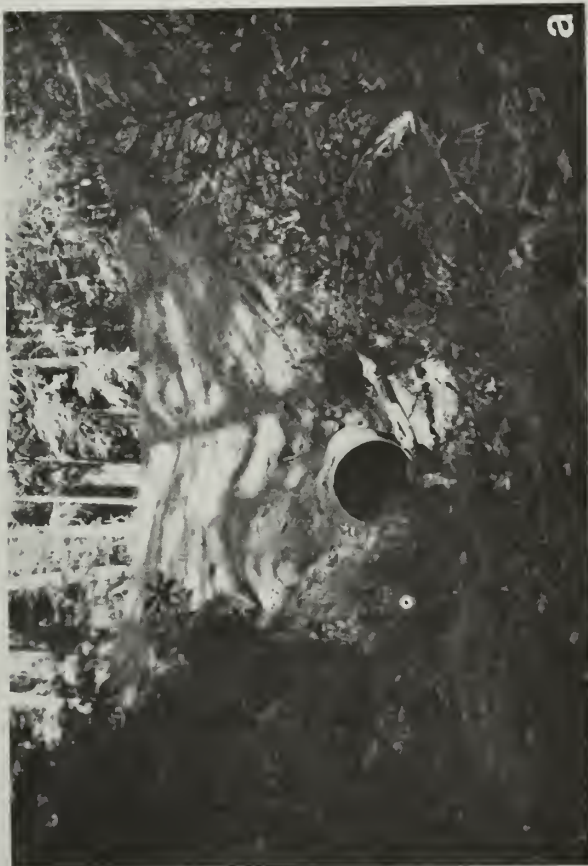
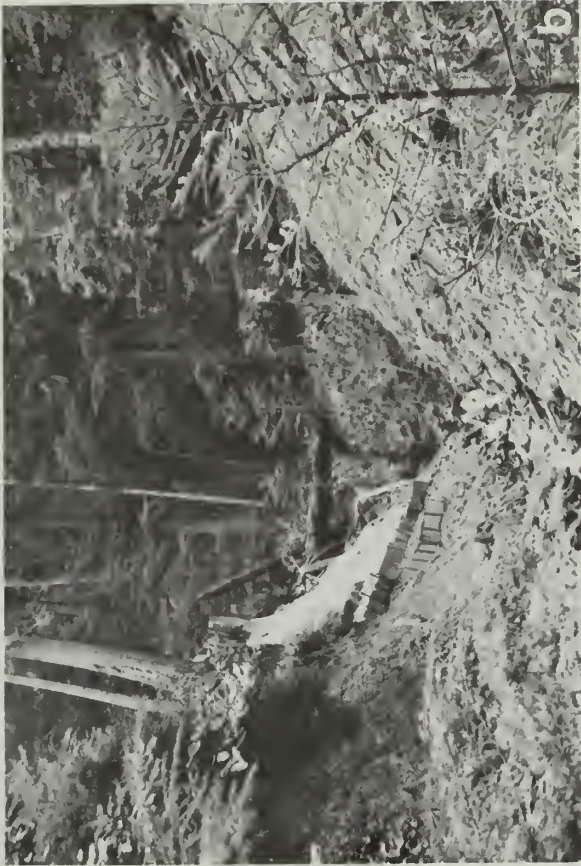
Fig. 26 (above). Excavation of stream crossing R9 at the end of the M-7-5-1 road. The fill material was primarily excavated by dragline crane. To complete the work, a backhoe was lowered to the channel bottom to finish detailed work on the stream bed. A) before treatment, (May 1979), and B) after excavation, (January 1980).

Excluding standby costs, the treatments (excavation by crane and end-hauling by dump truck) for stream crossings R6, R7 and R9 were appropriate and cost-effective. Unit costs for these excavations do not significantly vary from similar sized excavations which were end-hauled during 1982. Modifications resulting in some savings could have been made for the treatment of stream crossings R4, R5, R7A and R8. End-hauling was not necessary at crossing R8 and much of this excavation could have been accomplished by a crawler tractor at a lower cost. Also, greater use of a crawler tractor in place of a crane or backhoe would have resulted in lower costs at R4, R5 and R7A.

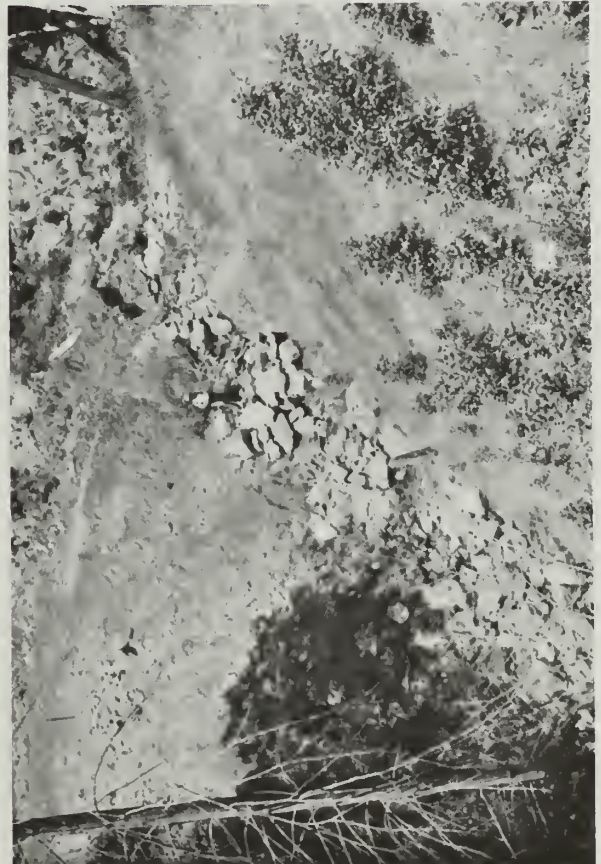
Fig. 27 (left). Heavy rock armor placed in the channel thalweg of excavated stream crossing R8. This treatment prevented subsequent erosion of the unexcavated material that still remained after heavy equipment work (July 1982).

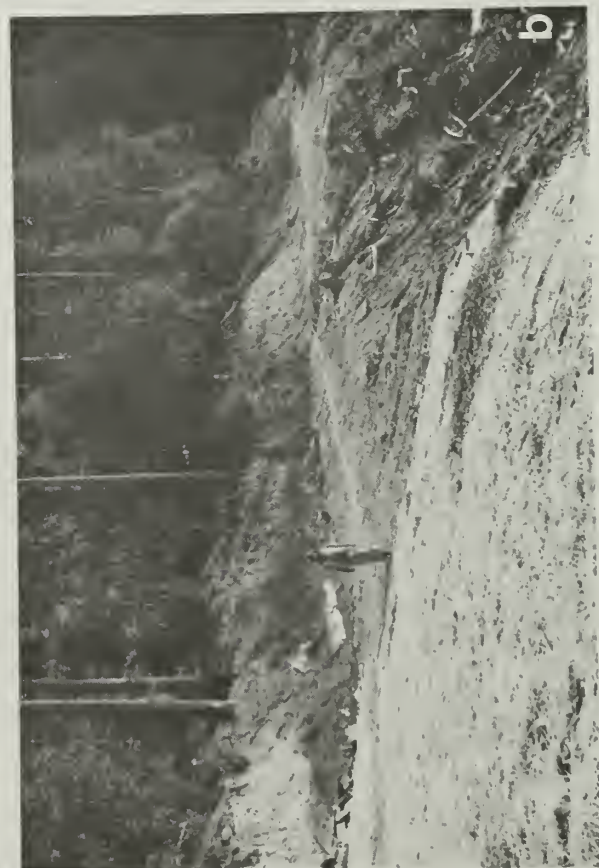
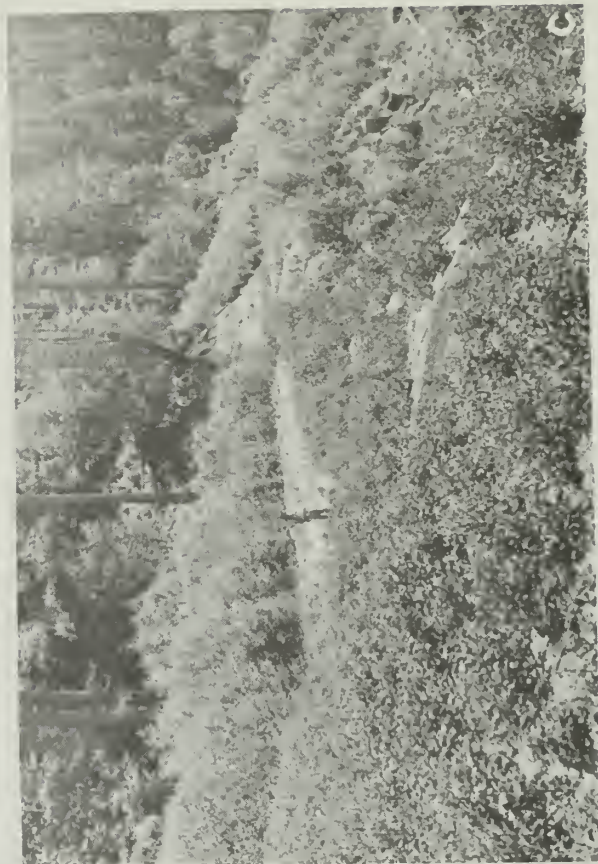
Fig. 28. Slight outloping of a segment of the M-7-5-1 road. This was the most common type of treatment applied to logging roads on this unit. A) before outloping (June 1979); B) after outloping and application of straw mulch (January 1980); C) natural invasion of alder (June 1984).

Approximately 1.2 miles of the M-7-5-1 road were slightly outsloped (Figure 28) and cross-road drained by the D-6 crawler tractor and backhoe for \$9,100 (Table 18), representing a unit cost of \$7,600 per mile. A dragline crane outsloped another 0.02 miles or 105 feet for \$1,800. Most of the road outsloping was accomplished by a crawler tractor. A backhoe was used for culvert removal, construction of cross-road drains and to pull back the outboard edge of the road at locations where it was awkward for the tractor to operate. The crane retrieved large concentrations of sidecast material to realign stream courses and remove culverts deeply placed in the road prism.

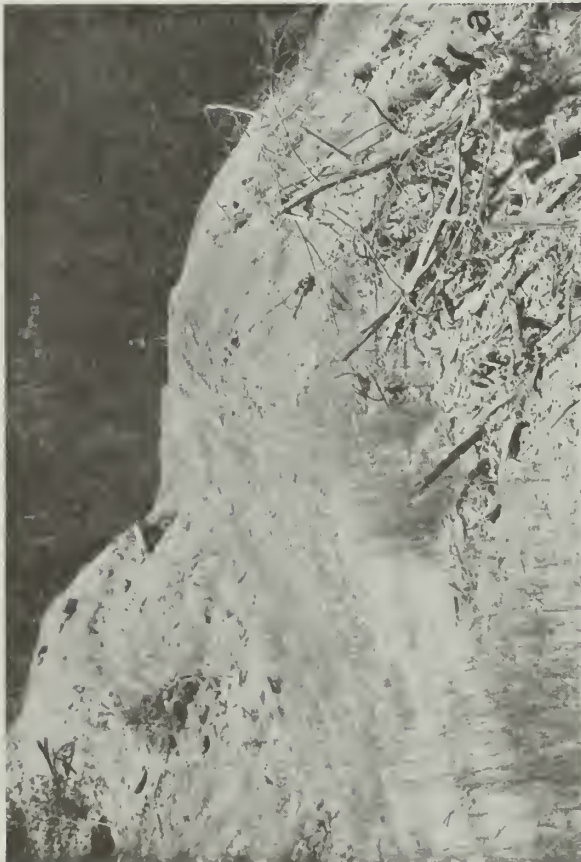
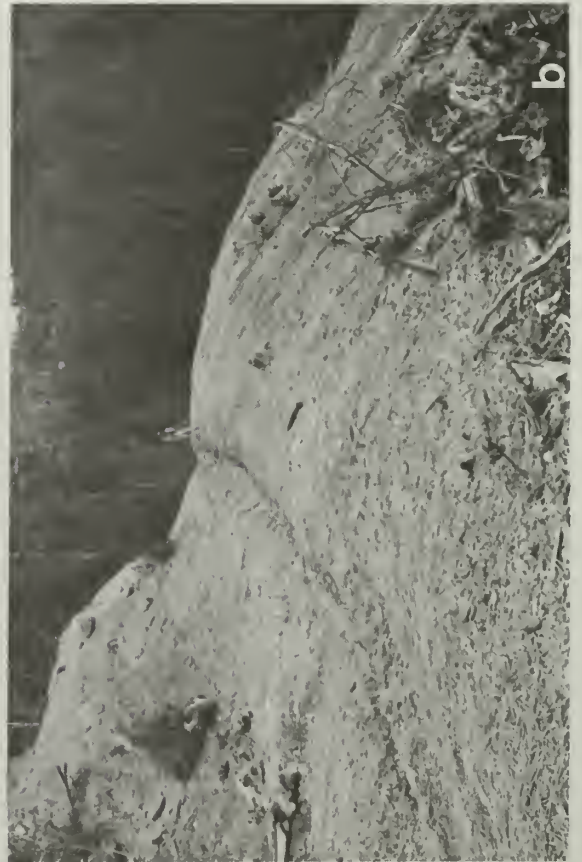
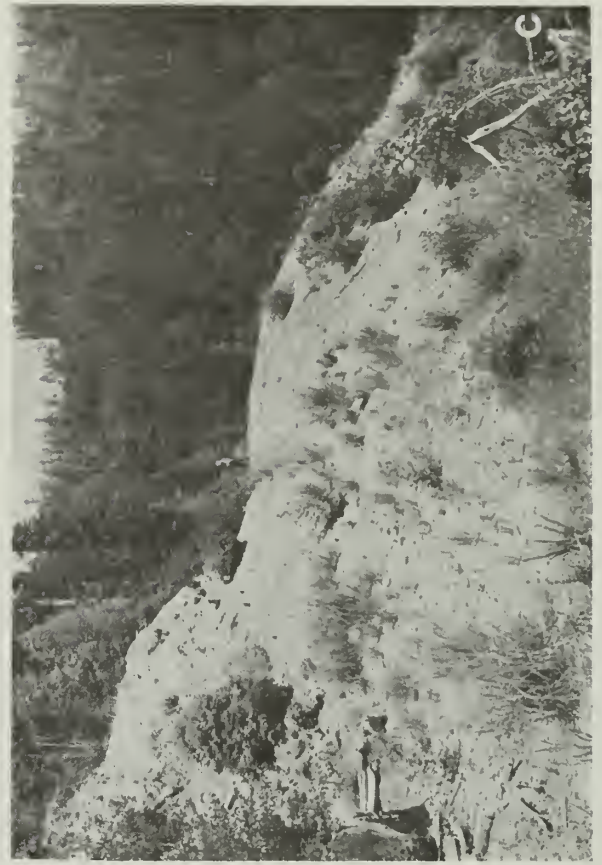
Fig. 29. Treated yarder pad above landing 2. A) before rehabilitation (note sparse revegetation) (June 1979); B) after outsliping and drainage improvements (January 1980); C) natural invasion of rushes and woody shrubs (August 1983).

Three yarder pads were ripped, outsloped and drained by the crawler tractor and backhoe (Figure 29) for \$3,400. A ditch system installed between pads 2 and 3 and outsloping of approximately 0.2 miles of access road is included in the cost.

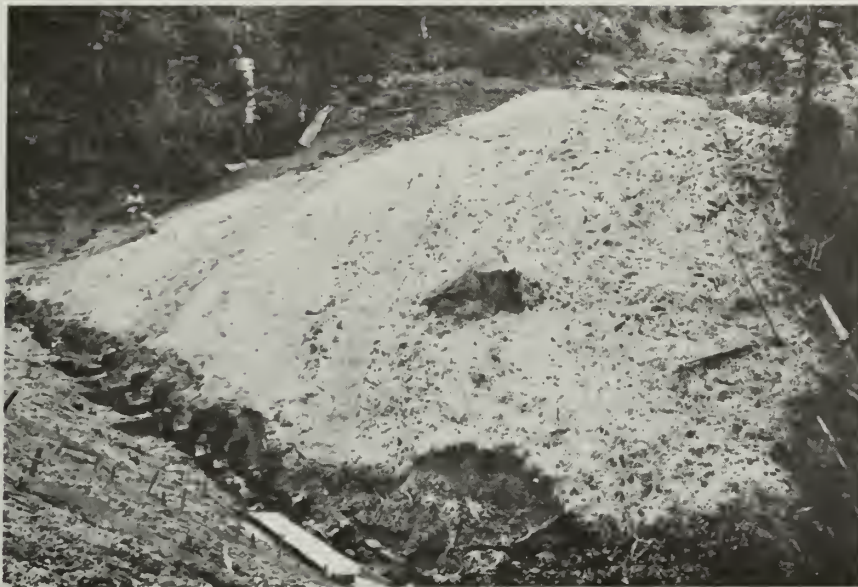
Fig. 36 (left). Surface erosion control on excavated stream crossing R7. The most cost-effective treatment for controlling surface erosion was the liberal application of straw mulch, secured by jute netting on slopes steeper than 70 percent. Photo shows same slope depicted in Figure 34.

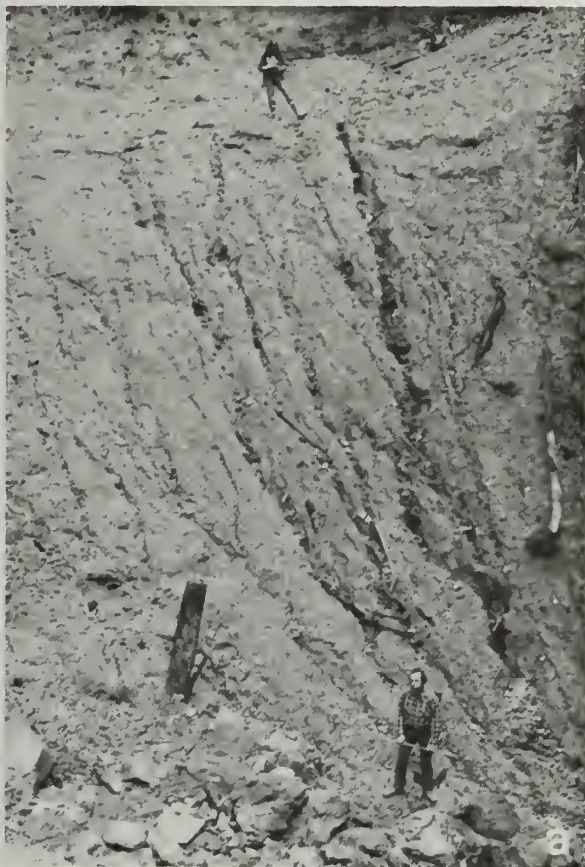
Fig. 37. Photos showing the left bank of excavated stream crossing 8A. A) after 5 inches of rainfall but prior to treatment for controlling surface erosion and B) during final stages of installation of jute netting over straw mulch. Once the original surface had rilled, it had to be manually raked (smoothed) before the jute and straw could be placed. No measureable erosion of the slope has since occurred.

Straw covered by jute was very successful in controlling rilling (Figure 37). However, the size and number of rills which developed on all treated sites were substantially reduced as compared to the same areas before treatment (immediately after the first fall rains). Following each winter, measurements showed that plots 3 and 4 (straw covered by jute and punched straw, respectively) actually trapped sediment which had been eroded from upslope areas. Plot 5 (straw mulch) reduced expected rilling by 85 percent and Plot 1 (wood chips) reduced predicted rilling by 13 percent (Table 23). There was less erosion with straw applied at 6,000 to 8,000 pounds per acre than with the 2,000 to 4,000 pound per acre rate. Wood chips prevented surface erosion on slopes less than 40 percent, but washed away and were ineffective on slopes steeper than 60 percent.

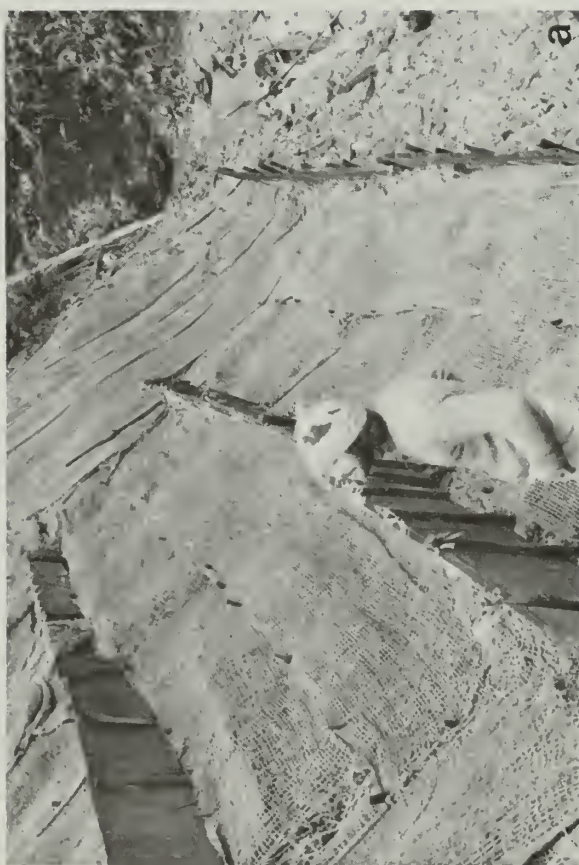
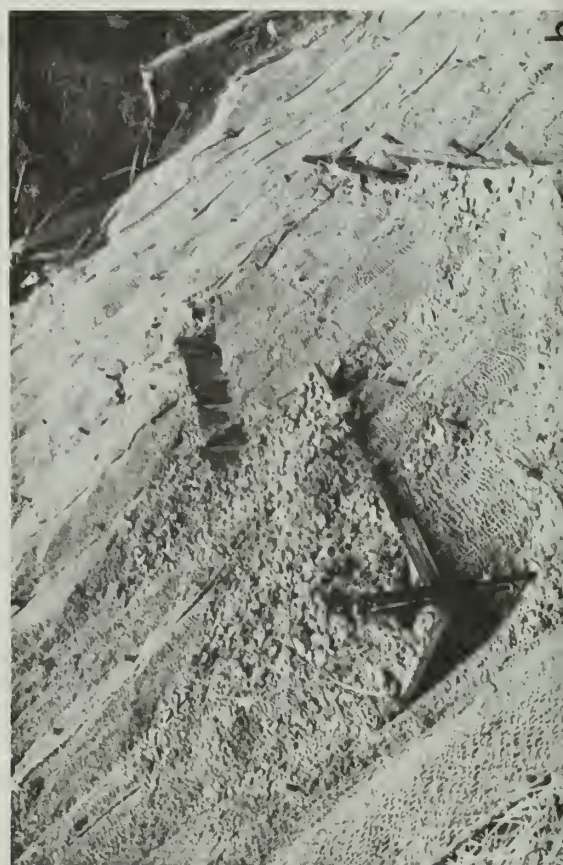
Fig. 38. Ravel catchers and jute-covered straw mulch on crossing R9. A) ravel catchers and jute-covered straw mulch were placed on the steep right bank of excavated stream crossing R9. B) following a small cutback failure on the former logging road at the top of the excavation, soil and rock passed over the jute (with no apparent damage) and either filled or toppled the ravel catchers.

was expected to be minimal, those structures were not repaired. Some rock armor at R3 was moved after streamflow had been diverted against the channel bank, but most of the material was too heavy to manipulate. Ravel catchers at crossing R9, which had been flattened by a small debris flow from a cutbank failure, were not re-built (Figure 38).

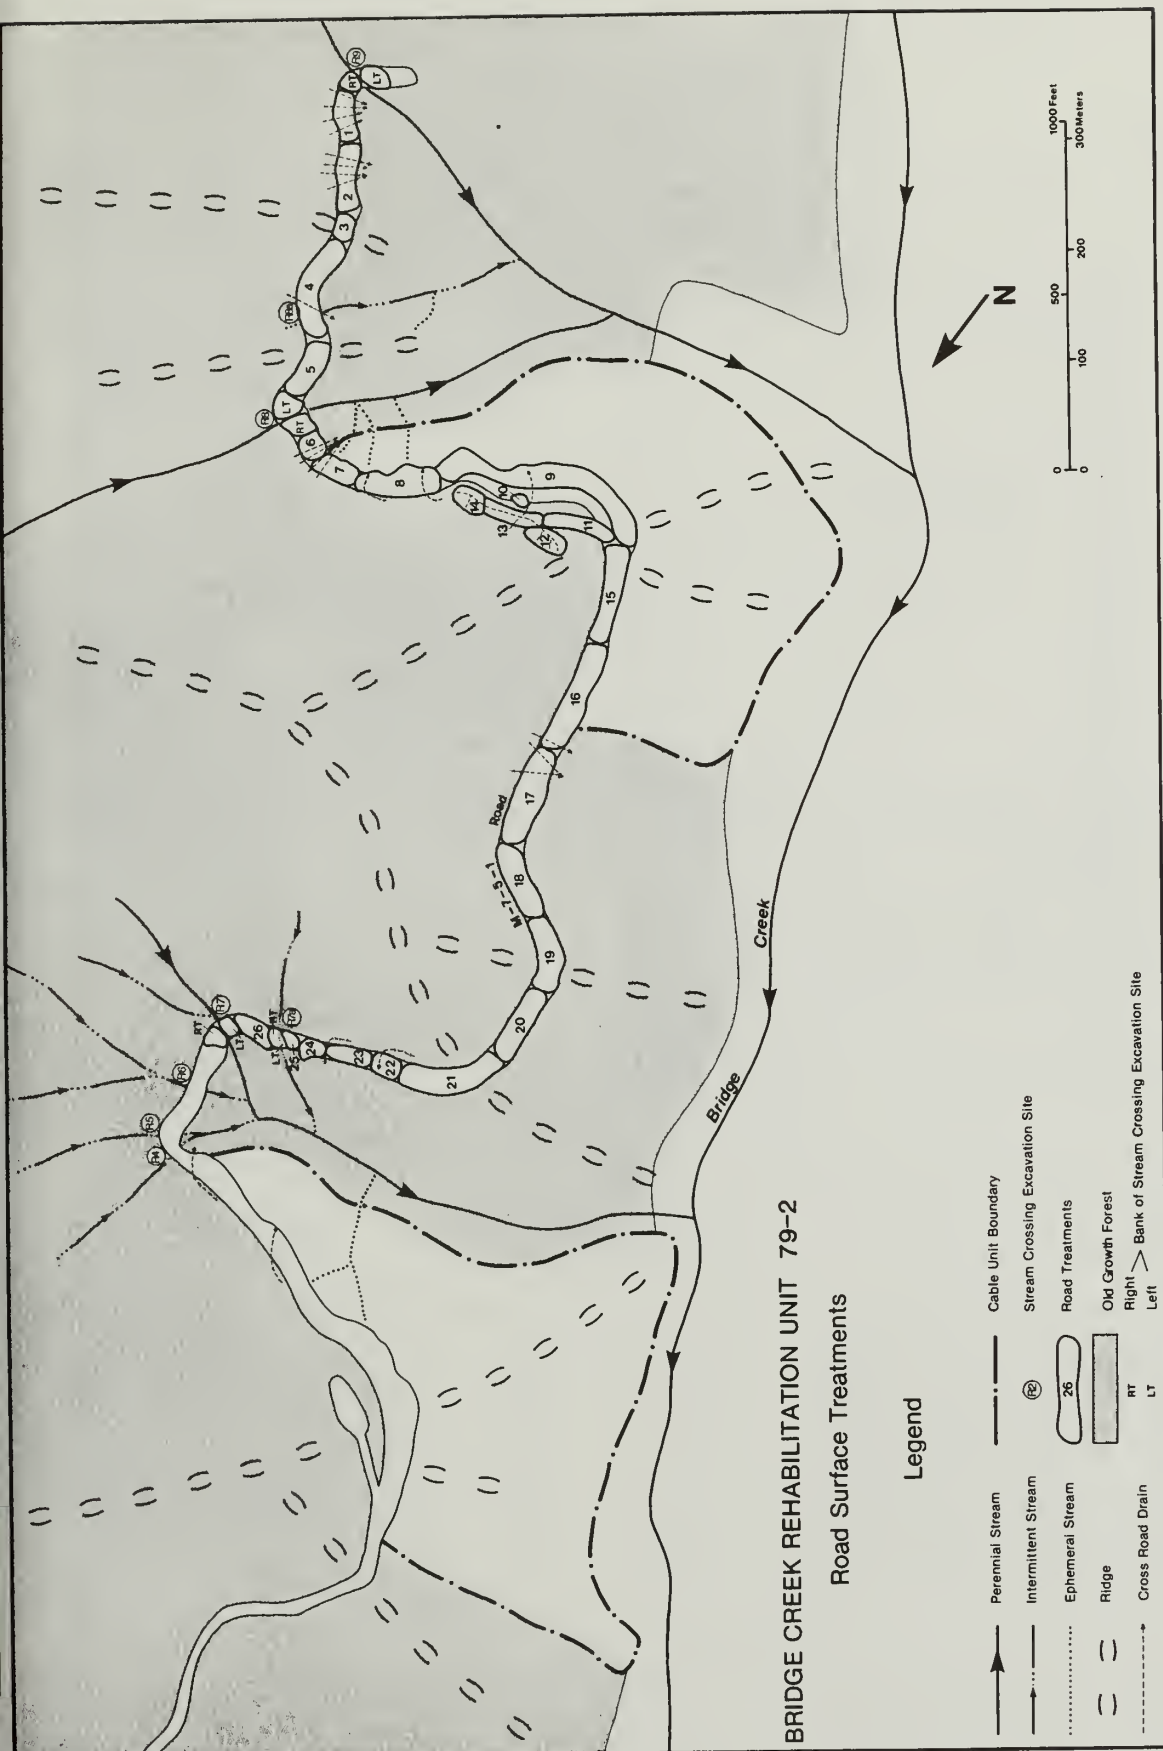
Fig. 39. Revegetation treatment plots established on the surface of the M-7-5-1 logging road following heavy equipment rehabilitation work. Surface treatments included grass, grass and fertilizer, straw mulch, wood chip mulch and untreated control plots (Table 21).

Experimental treatments of grass seed, fertilizer and straw mulch were applied to most of the road surface in November 1979 (Figure 39 and Table 21). Grass seed and fertilizer were also applied at stream crossing excavations R7, R7A, R8 and R9. The RNP grass mixture was applied at 50 pounds per acre and 16-20-0 fertilizer was applied at 250 or 500 pounds per acre.

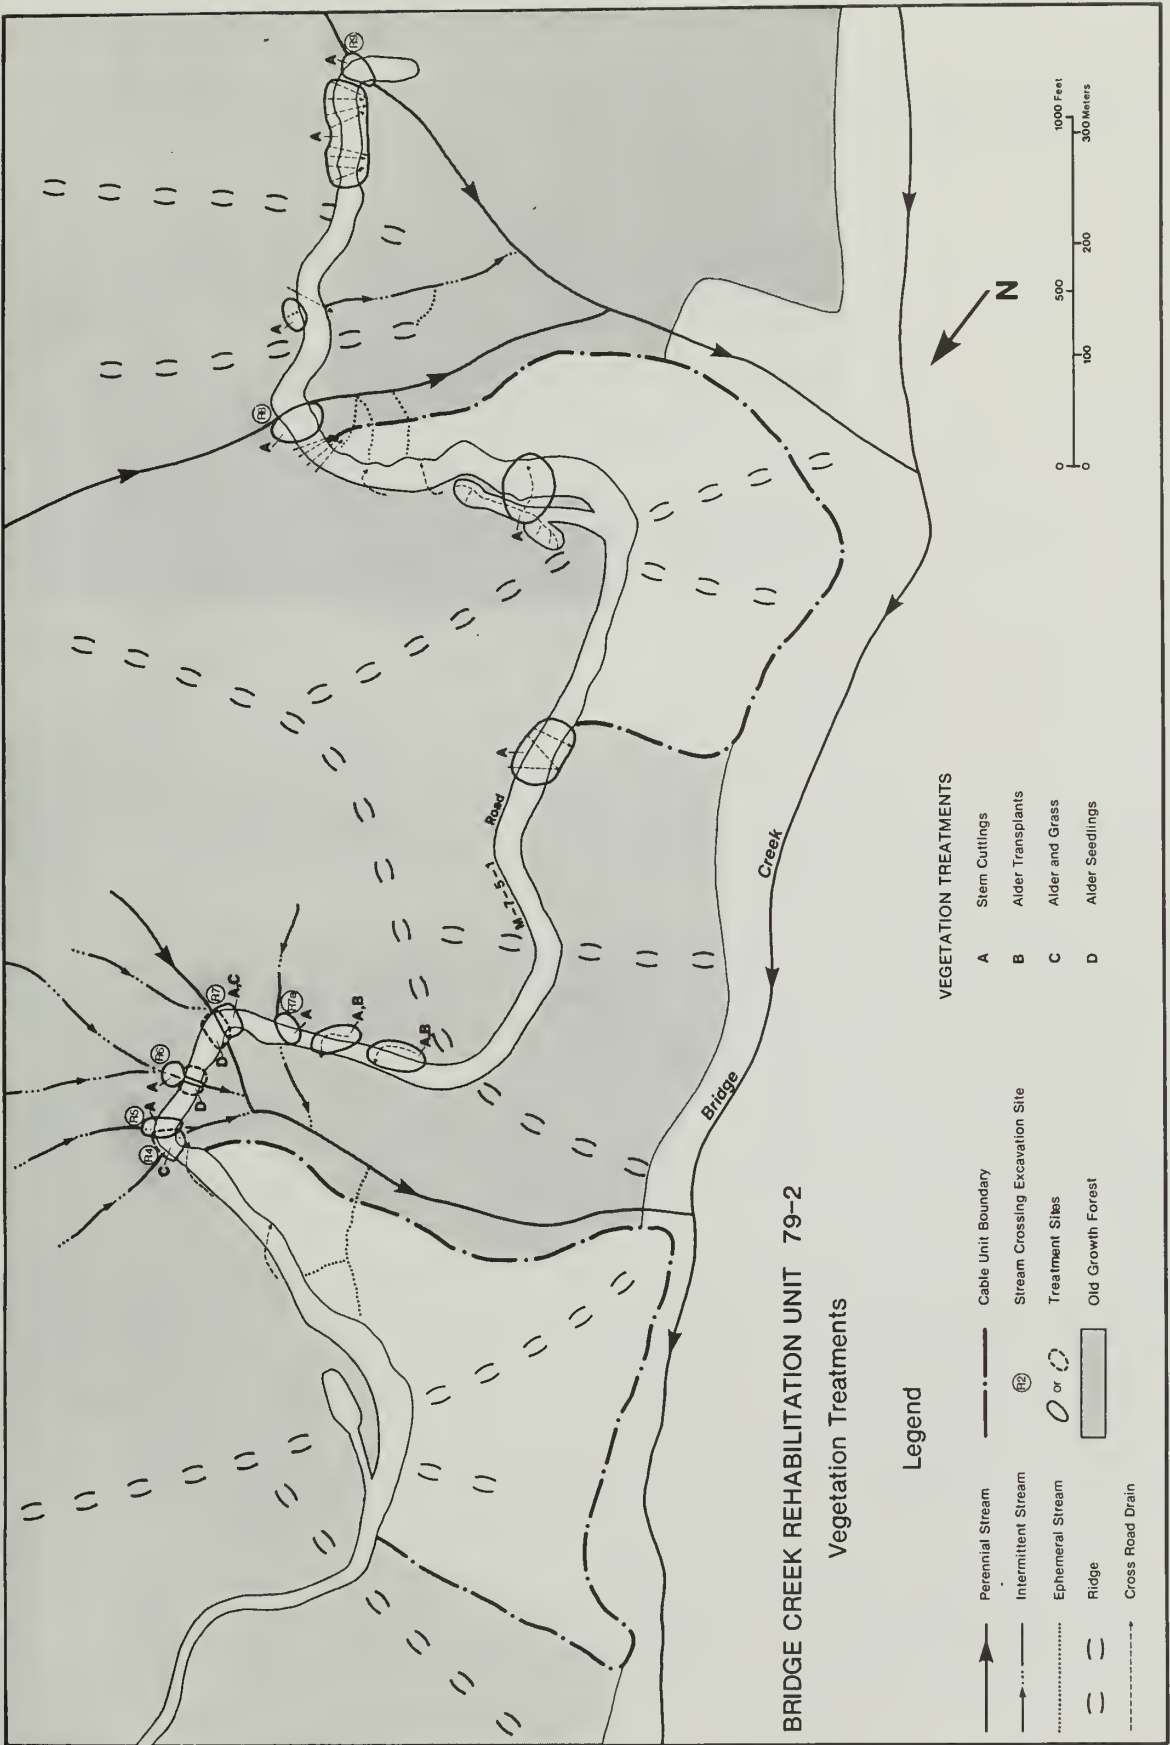
Fig. 40. Vegetation treatments, M-7-5-1 logging road.

Over one-thousand willow stem cuttings were planted at 14 moist areas (Figure 40). Source for cuttings was near the Redwood Creek trailhead at Orick. On-site alder seedlings were transplanted at two sites. One-year old containerized alder seedlings grown by Simpson Timber Company were planted at R6 and R7. Twenty-six pounds of a grass/alder seed mixture were sown at stream crossings R4 and R7 in April 1980 (Figure 41). The grass/alder seed mixture was composed of 25 pounds "RNP mix" and one pound alder seed.

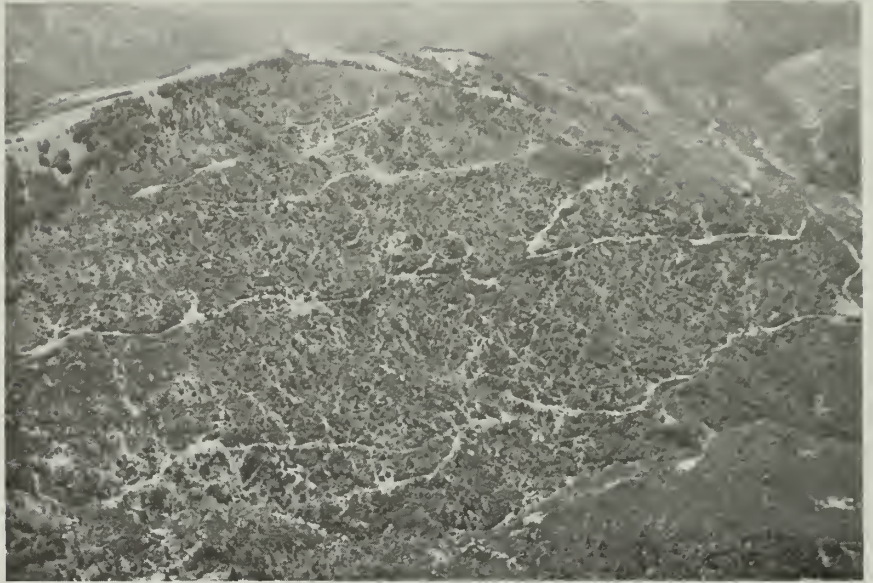
Fig. 46 (above). Oblique aerial photograph of the Copper Creek rehabilitation unit (August 1979). Most areas, except logging roads, major skid trails, landslides and large gullies have revegetated in the decade since the area was last logged.

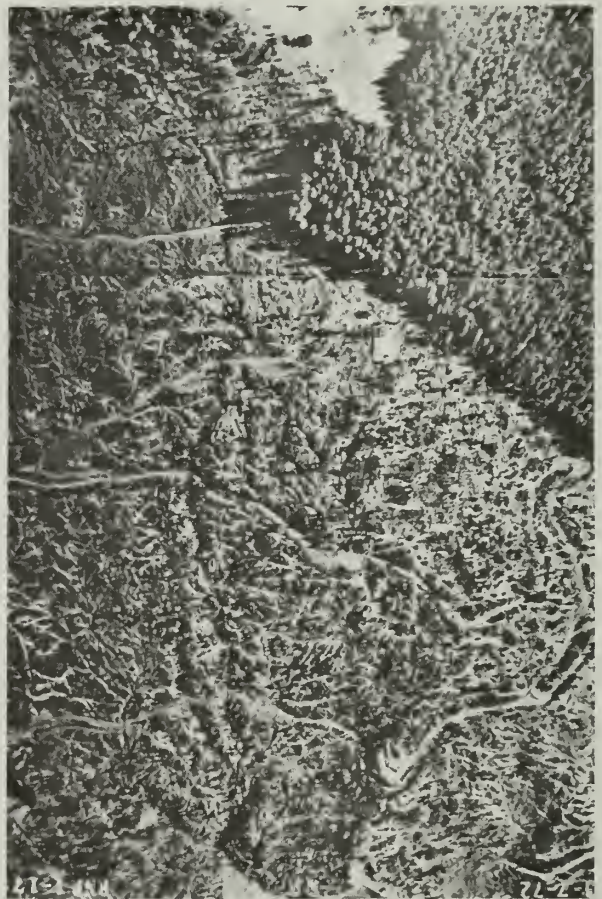
Fig. 47 (right). Vertical aerial photograph of the south west portion of the Copper Creek site just following the 1972 storm and flood. Note the high degree of ground disturbance in the tractor logged areas. The remaining forest in the upper portion of the photo was clear-cut the following year.

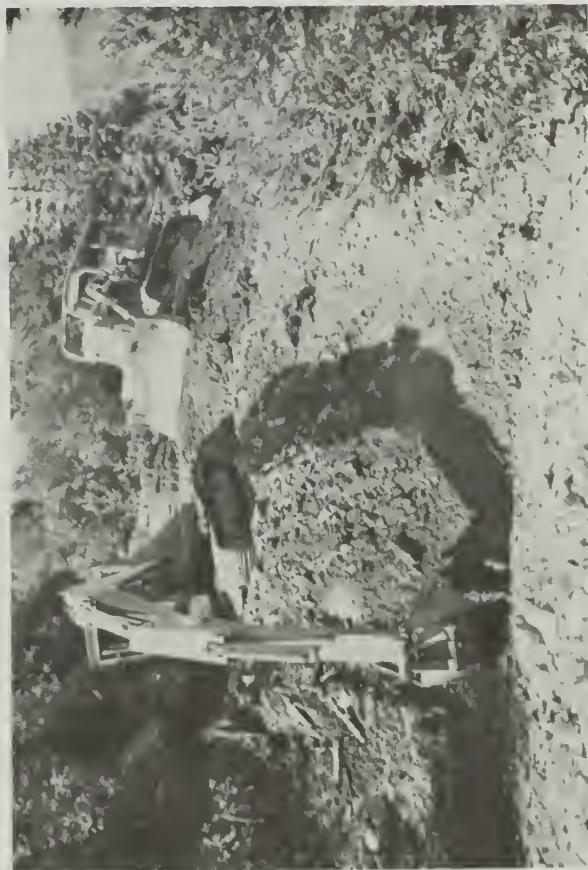
Fig. 53 (above). D-8 sized crawler tractor excavating debris from a stream crossing. As shown here, tractors were used to perform initial excavation work at a number of stream crossing sites. In recent years, many crossings have been entirely excavated using only crawler tractors to both excavate and remove material.

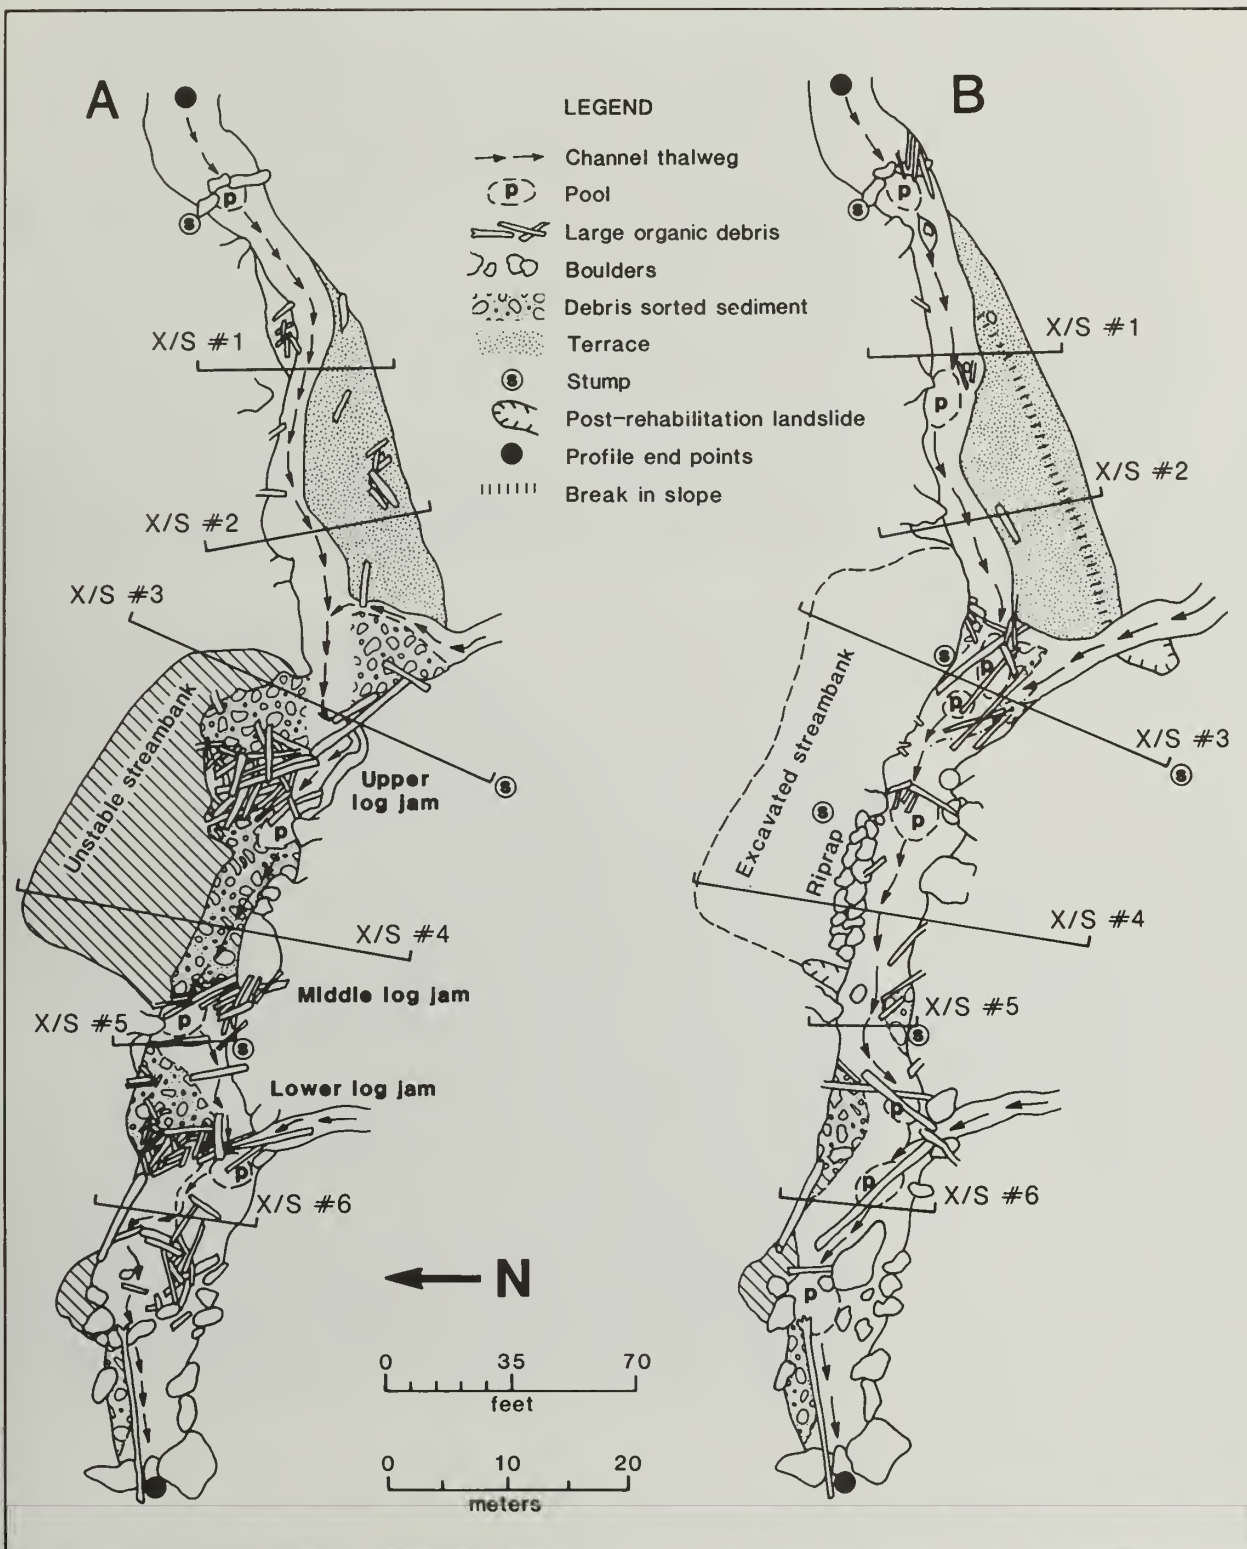
Fig. 58. Morphologic maps of Copper Creek in the vicinity of the log jam. A) before rehabilitation (September 1979), showing the distribution of stored sediment, organic debris and locations of bank erosion, B) after rehabilitation (August 1982) showing the channel adjustments which had occurred in the subsequent winter.

Organic debris and log jams commonly alter the hydraulics of a stream reach causing changes in channel morphology (Pitlick, 1981; Keller and Talley, 1979; Swanson and Lienkaemper, 1978). An abrupt step in the longitudinal profile may form at the log jam with an associated upstream decrease in gradient and increase in channel width. These effects were seen at the Copper Creek log jam worksite. The log jam also caused local hillslope failure by diverting flow into banks and undercutting the toe of an adjacent slope (Figure 58).

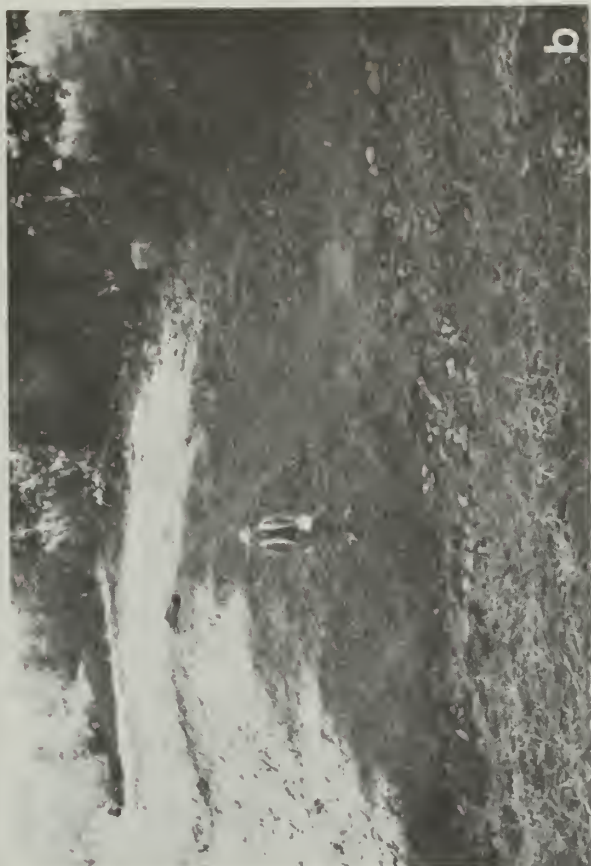
Fig. 64. Successful, minor stream crossing excavation. A) gullied stream crossing on abandoned logging road (August 1979); B) excavated crossing after several storms; note the low channel gradient, gentle side slopes and minimal widening (scour) of the channel bed (December 1979); C) same view after approximately four years, note the rapid, natural invasion of alder on the decompacted road surface (September 1983).
